**PEQUONNOCK RIVER BASIN  
BRIDGEPORT, CONNECTICUT**

**FOREST LAKE DAM  
CT 00078**

**PHASE I INSPECTION REPORT  
NATIONAL DAM INSPECTION PROGRAM**

**AUGUST 1978**

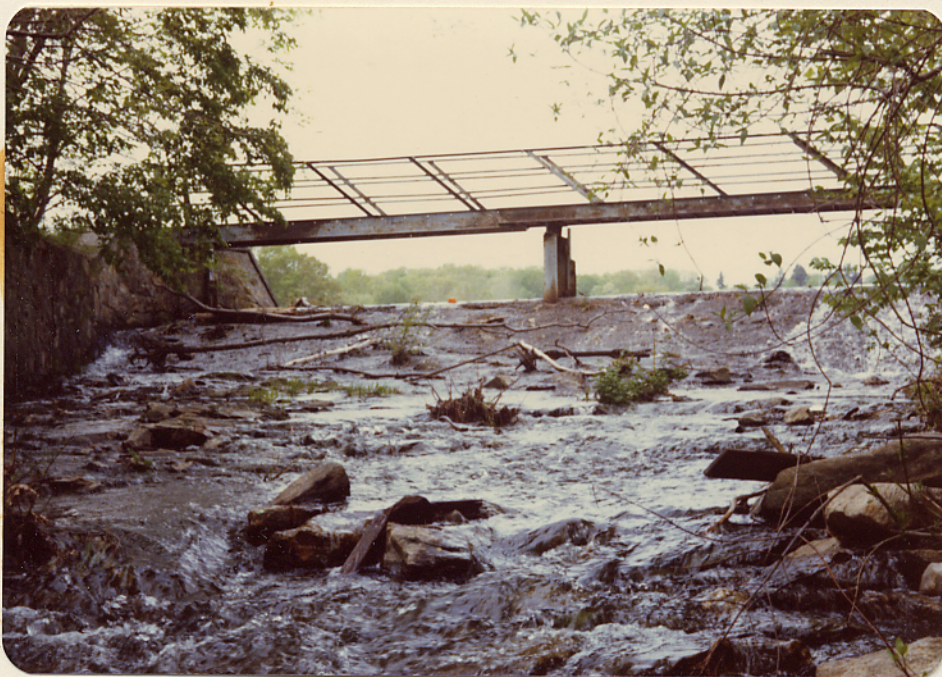
e. Downstream Channel - The spillway channel has low stone walls within about 50 feet of the spillway. The left wall has partially collapsed while the right wall is in good condition. The channel is strewn with boulders, and there are some tree branches which have fallen into the stream. Heavy tree and bush growth next to the channel can, in the future, result in additional branches falling into the channel.

PHOTO NO.1 - Outlet spillway channel, note tree branches and other debris.

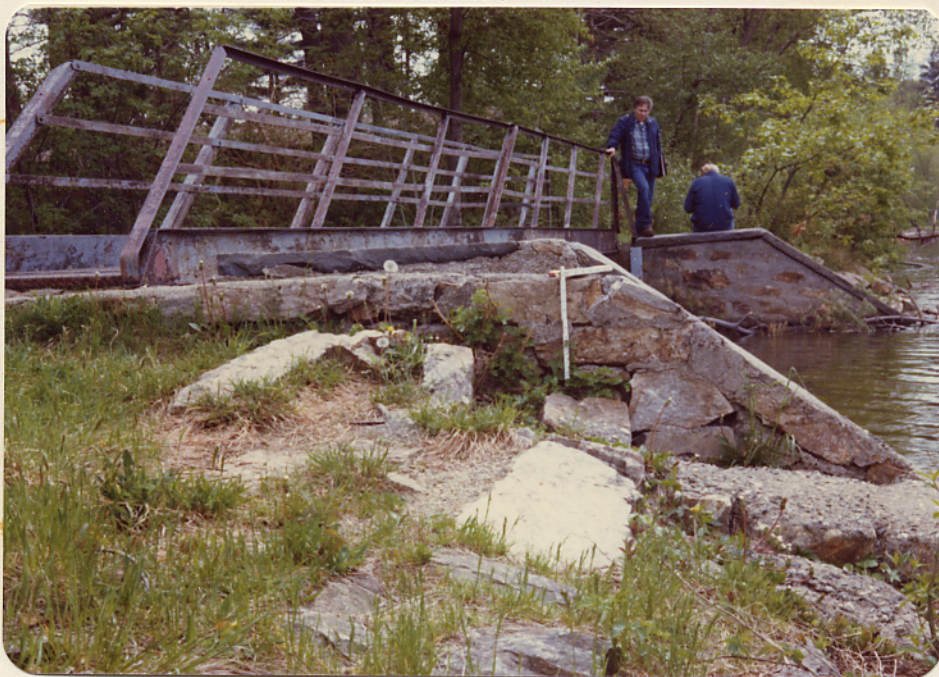
b. The top portion of the upstream slope and the adjacent crest section at the spillway retaining walls have settled or eroded and would cause concentration of water flow if the reservoir level were to approach the crest of the dam. This would increase the possibility of localized erosion and washout at this point

PHOTO NO.2 - Embankment at spillway wall.

2. The top portion of the dam should be returned to its original grade and rip-rapped condition next to the spillway.
3. Obstructions should be removed from the outlet pipe.

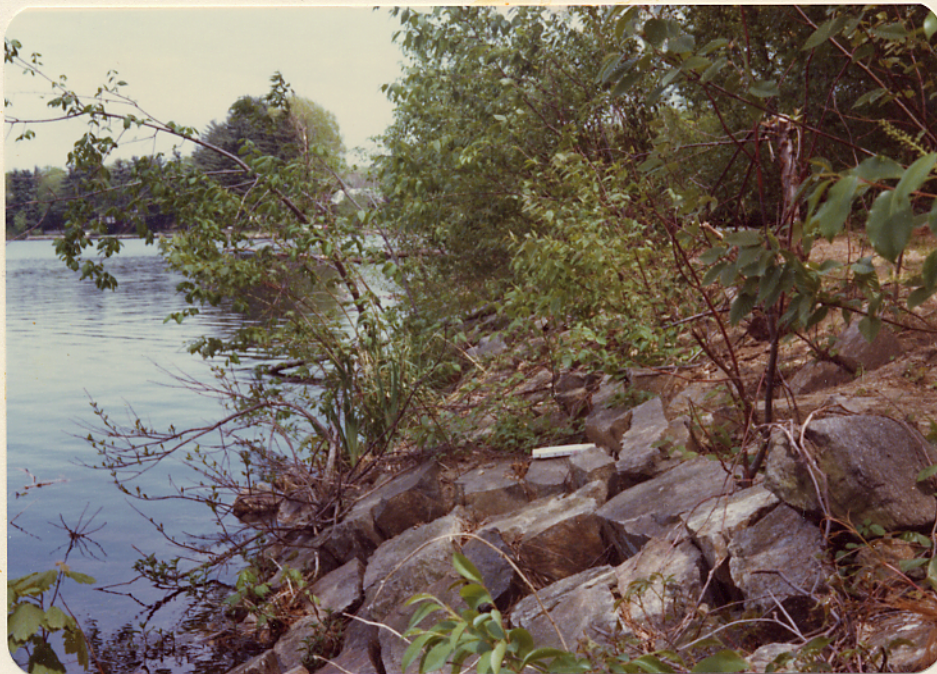
a. The trees and bushes growing on the crest, upstream and downstream slopes of the dam present a potential seepage problem. The roots can create seepage paths for the water, particularly after the trees die. Uprooting of trees during windstorms could cause embankment problems

PHOTO NO.3 - Riprap, right of spillway, showing vegetation growth.

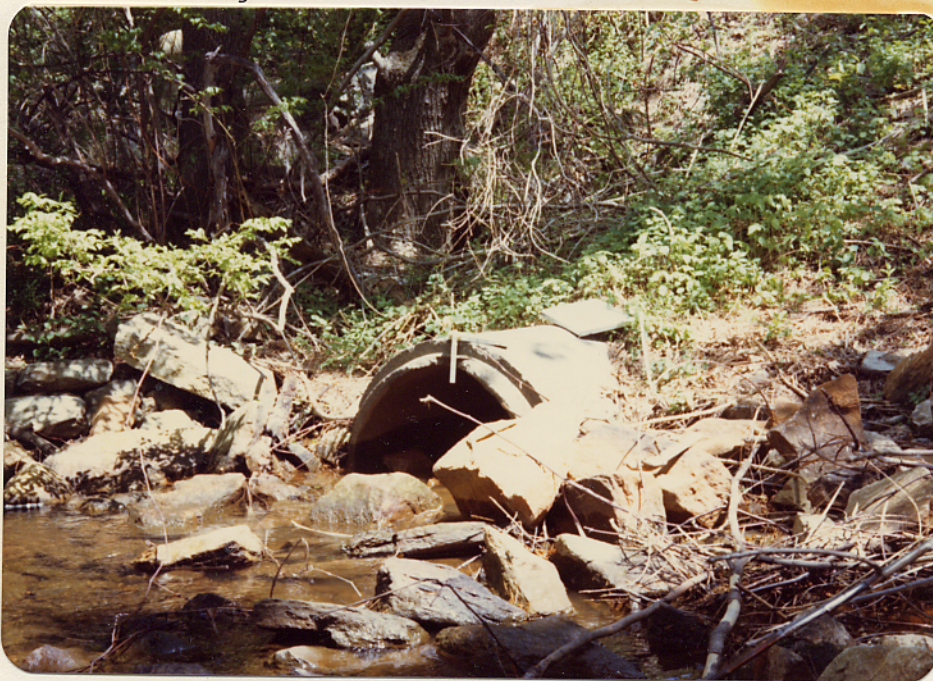
AREA EVALUATED	BY	CONDITION
General Condition of Concrete	-	
Rust or Staining on Concrete	-	
Spalling	-	
Erosion or Cavitation	-	
Cracking	-	
Alignment of Monoliths	-	
Alignment of Joints	-	
Numbering of Monoliths	-	
Conduits	GC	Outlet conduit is blocked at outlet to about its mid height.

PHOTO NO.4 - Outlet conduit, partially obstructed.
